Airworthiness Directive

Amendment 39-2372; AD 75-20-06

Airworthiness Directives; Bellanca Model 17-30, 17-30A, 17-31, **17-31TC**, 17-31ATC, 14-19-3A, and 17-31A Airplanes

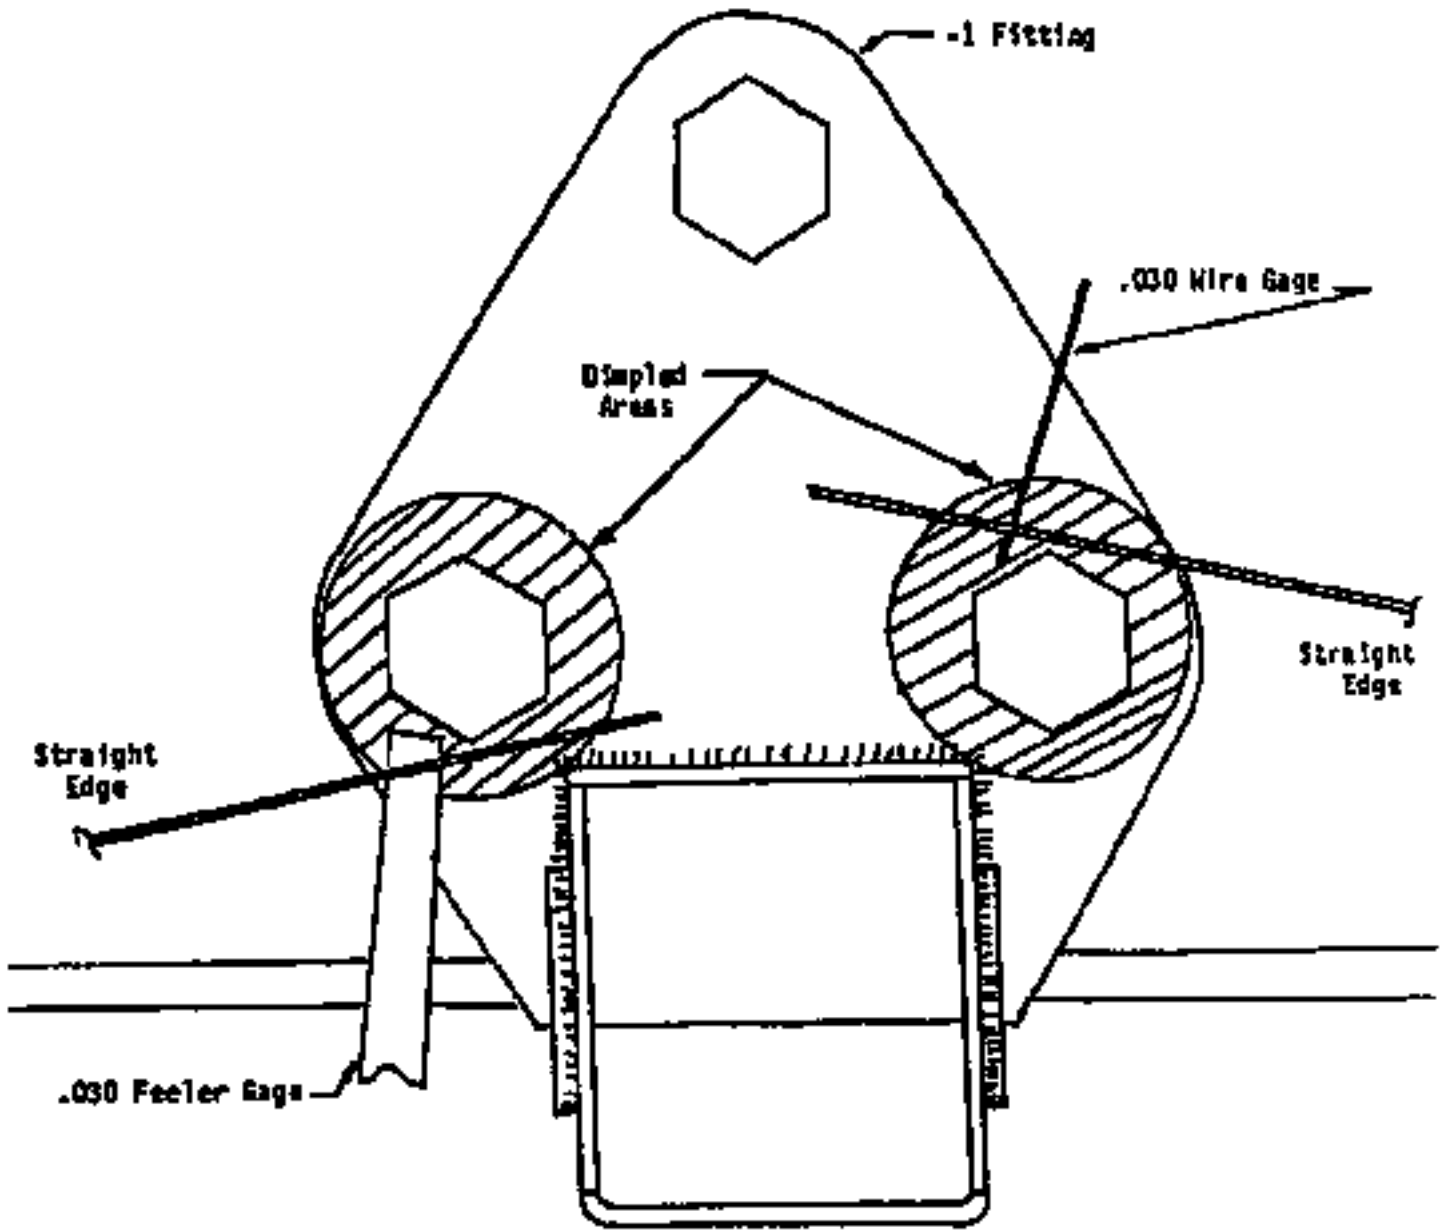
FIGURE 1

(a) Upon the accumulation of 500 hours total time-in-service (TIS), or within the next 100 hours TIS after the effective date of this AD, whichever occurs later, and each 100 hours TIS thereafter, inspect the left and right drag strut landing gear fitting assemblies, Part Number (P/N) 194153-10, for cracks, deformations, or failures as follows:

(3) Inspect for cracks adjacent to the welds which join the -1 fitting to the -2 fitting and -3 brace near the lower aft attachment bolt holes using liquid penetrant inspection techniques and a magnifying glass. If any crack is found, prior to further flight replace the assembly with a new fitting assembly, P/N 194153-30 or P/N 194153-40, as applicable.

(4) Lay a straight-edge along side the lower aft attachment bolts, in accordance with Figure 2 and, using a feeler gage or wire gage of .030 inch thickness, look for any evidence of local deformation (dimpling) in the -1 fitting. If any deformation greater than .030 inches is found, prior to further flight replace the assembly with a new fitting assembly, P/N 194153-30 or P/N 194153-40, as applicable.

(b) Airplanes with cracked or deformed fittings may be flown with a special flight permit in accordance with FAR 21.197 to a location where this AD may be accomplished providing that no crack is found during the inspection of paragraph (a)(3) that exceeds 3/8 in. length, or no deformation is found during the inspection of paragraph (a)(4) that is great enough to cause the overcenter of the drag strut to be out of tolerance. In these cases, no special flight permit is allowed.
